SUMMARY OF FRICTION AND WEAR DATA

Project Number: **723952**

September 24, 2004

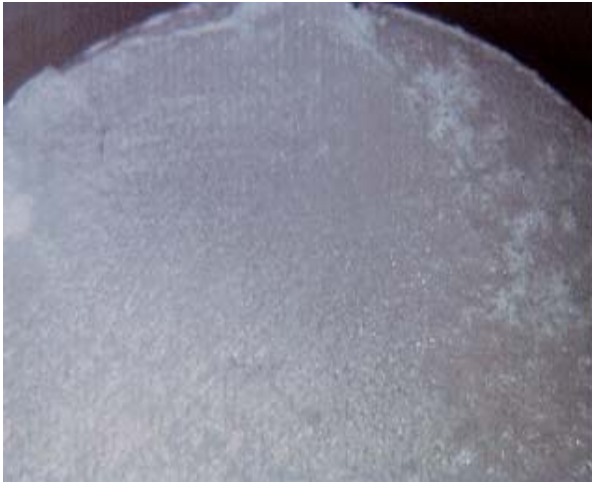
723952A pin at 50x
(painted prior to test)

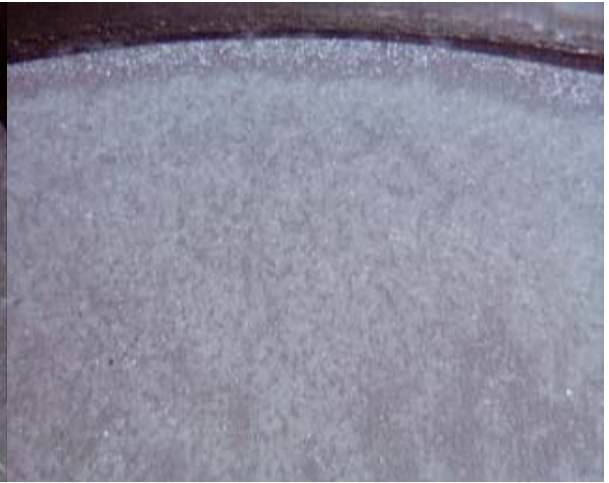
723952A disk at 50x
(no mark in paint coating)

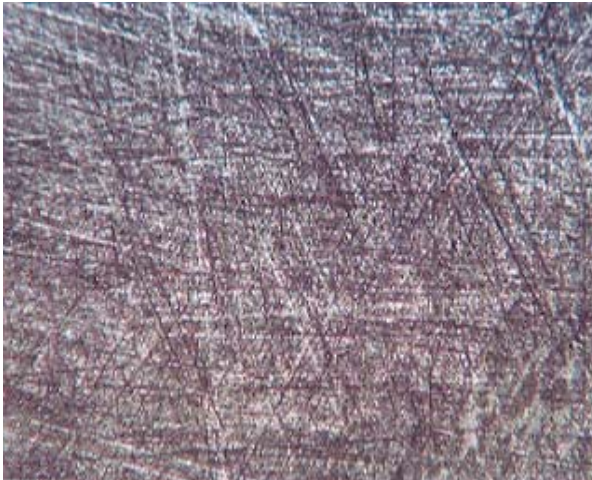
723952B pin at 50x
(direction of motion is horizontal-
random 600 pattern still visible)

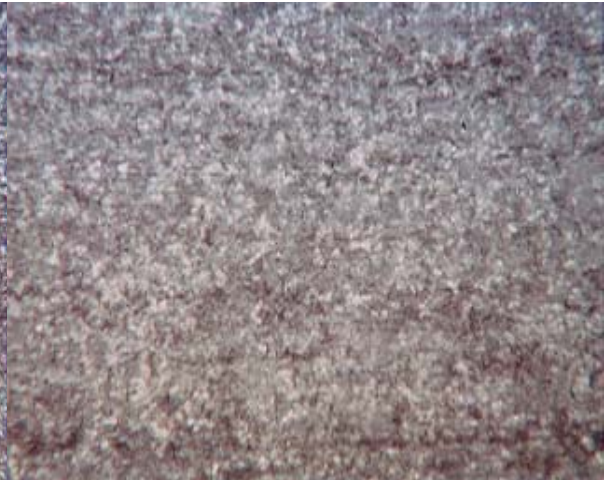
723952B disk at 50x
(lighter area is impression in paint coating)

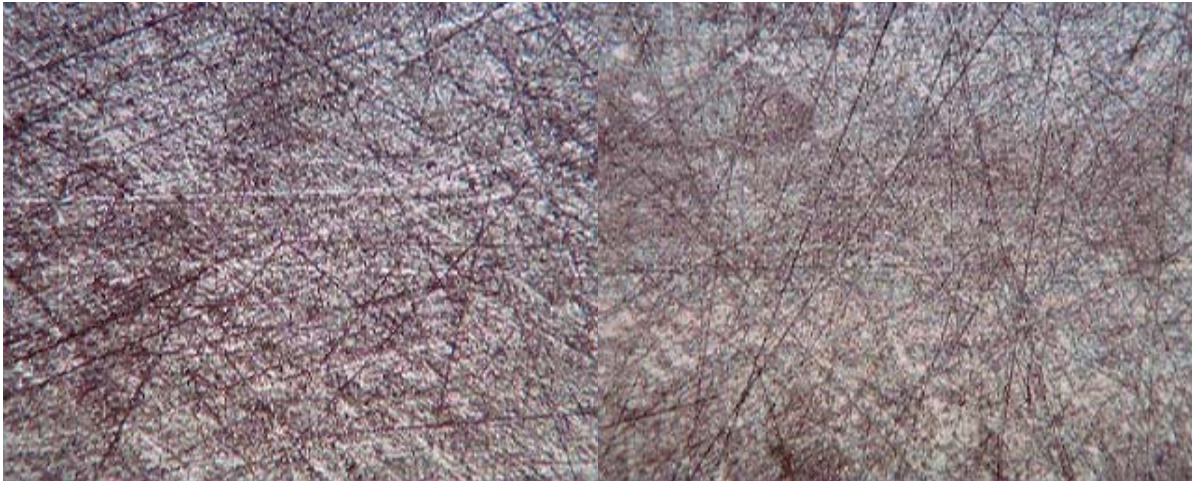
723952C 5" radius pin at 50x
(direction of motion is horizontal –
scar contrast is barely visible)

723952C disk at 50x

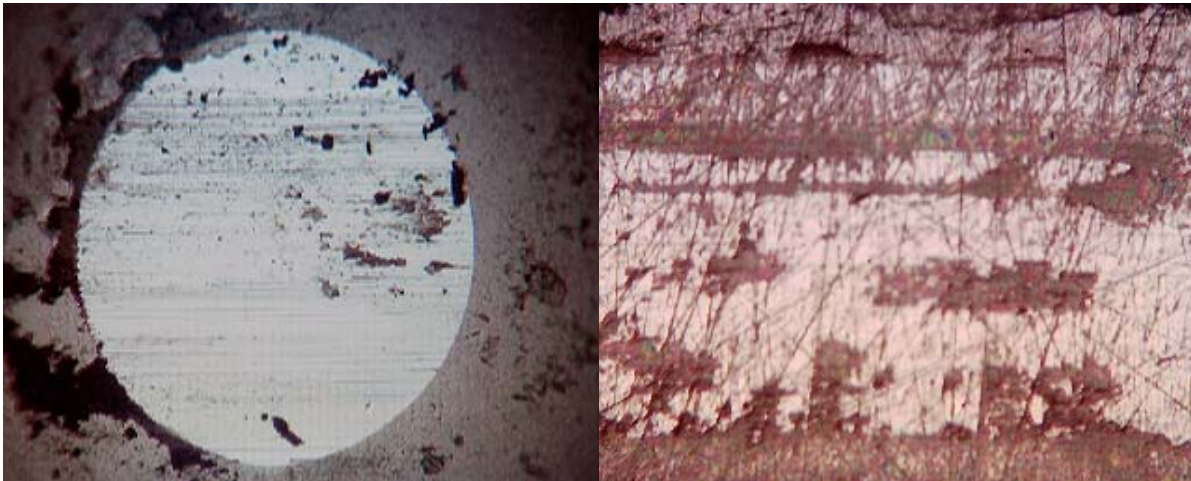
The scar on the ¼" pin of test D was bare metal. There appeared to be very little or no metal removal at all from the track on run D. The track disappeared simultaneously with the paint upon re-polishing the disk after analysis.

723952D 1/4" radius pin at 100x

723952D disk at 100x
(gold-brown film is mostly at edges of track)
